Freelander 1

Ball Joint Replacement

FITTING INSTRUCTIONS

Part Number - RBJ500680BJ / RBJ500690BJ

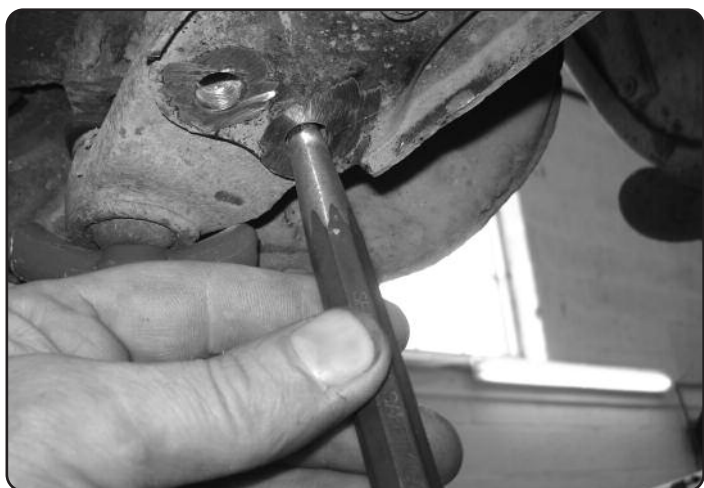
Undo the ball joint nut and brake the taper lock using a ball joint splitter or a hammer and a pry bar.

Using a angle grinder grind off the heads of the three rivets underneath the arm, then using a hammer and punch drive out the rivets.

If they will not move mark the centre of the rivet and drill a 10mm hole approx 12mm deep into the rivet then drive the rivet out with a hammer and punch.

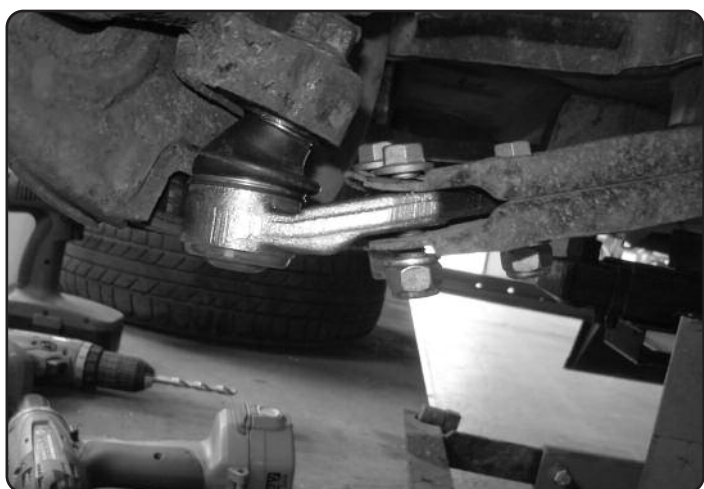
Lever down bottom arm and remove the old ball joint.

Fit new ball joint with the three M10 nuts and bolts provided and tighten the bolts to 40lbs ft.

Fit ball joint nut and tighten to 48lbs ft (if nut turns and will not tighten place a jack under the arm and apply some pressure until the nut will tighten up).
